Field Report for Airborne Data Collected In Support of US EPA Region 6 Intercontinental Terminals Company LLC Fire 3 April 2019

Data Results Flight 20, 3 April 2019

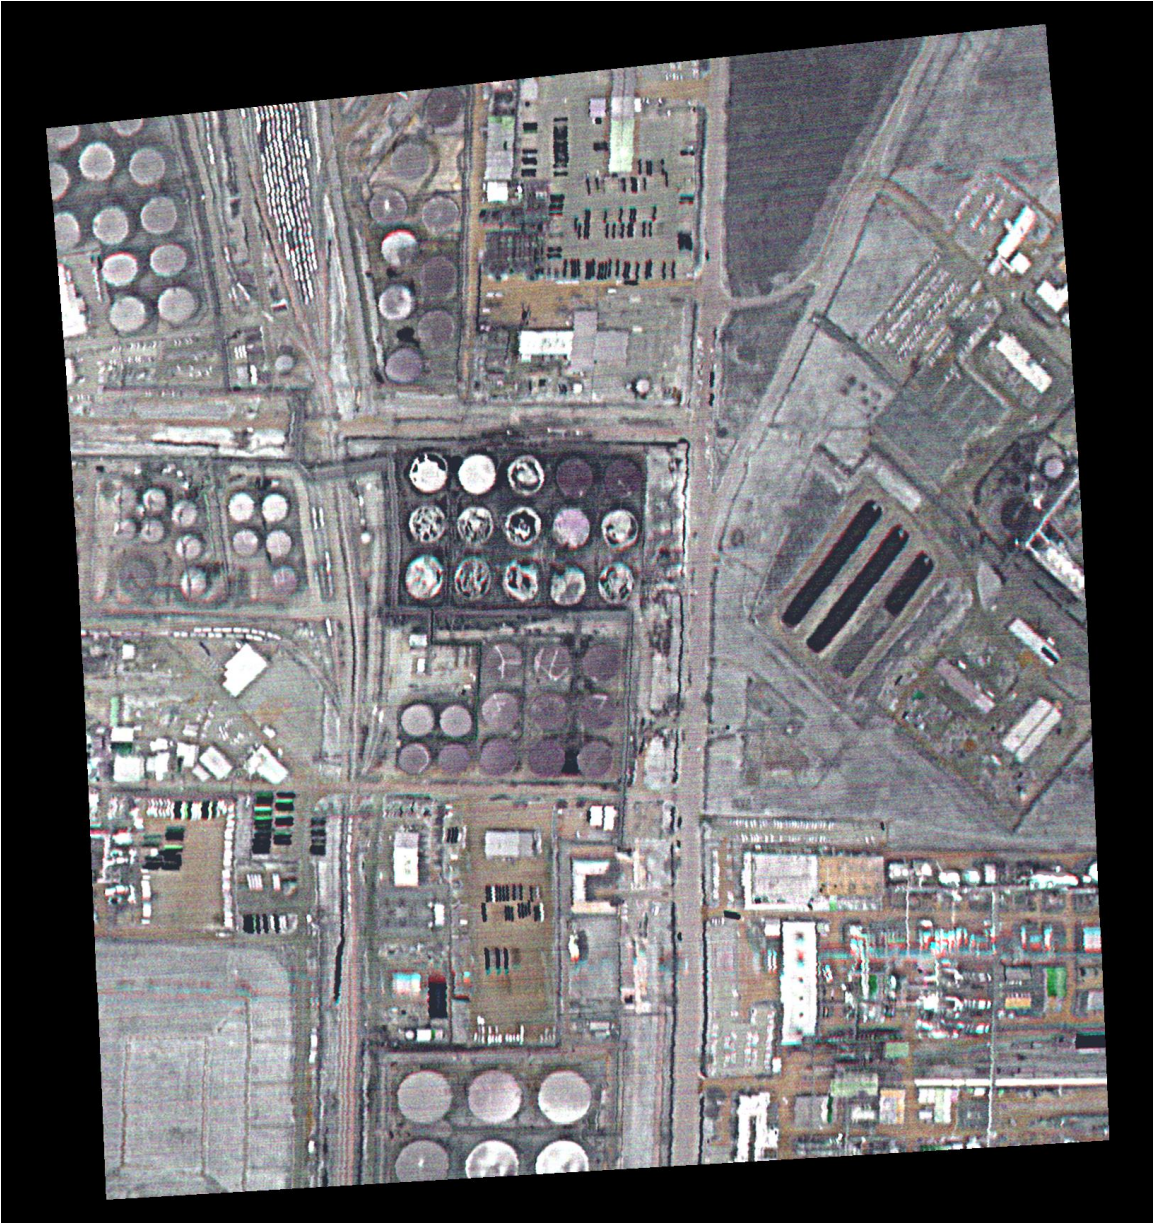
A total of 1 test and 5 data passes were made in the proximity of the impacted tank farm and also in extended areas surrounding the site and infrared line scanner images were generated for each pass. Figure 3 shows a typical 3-band infrared image obtained from data collected for Run 5. IR imagery of the tank farm indicates that all tanks are at ambient temperature other than IR solar heating on portions of the western structures.

Figure 3: IR image of ITC data for 3 April 2019, Flight 20, Run 2

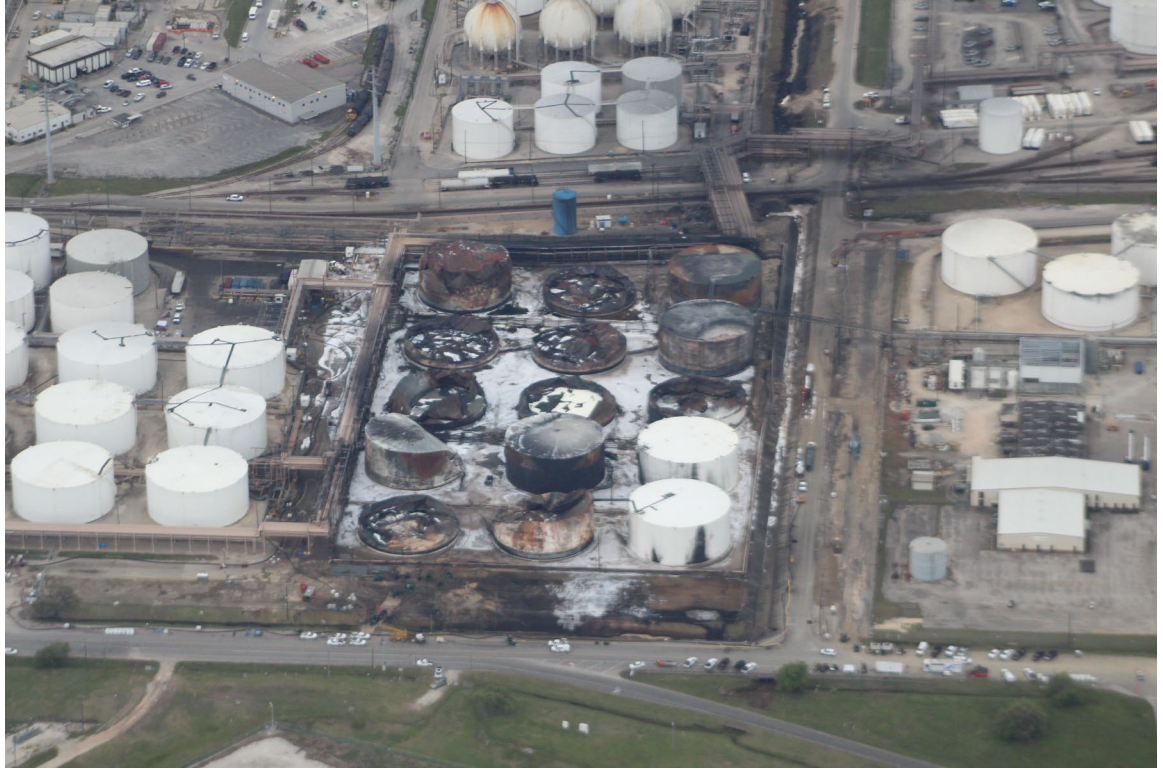
A full set of high resolution aerial digital photography was collected as part of the flight. Figure 5 shows a representative overhead image collected as part of each pass over the tank farm. Analysis of the image shows no change from imagery collected on 3 April 2019. Figure 6 shows an oblique image of the tank farm and confirms no change from the 2 April 2019 flight.

Figure 6: Oblique Image of the Tank Farm (looking south) , 3 April 2019 Flight 20

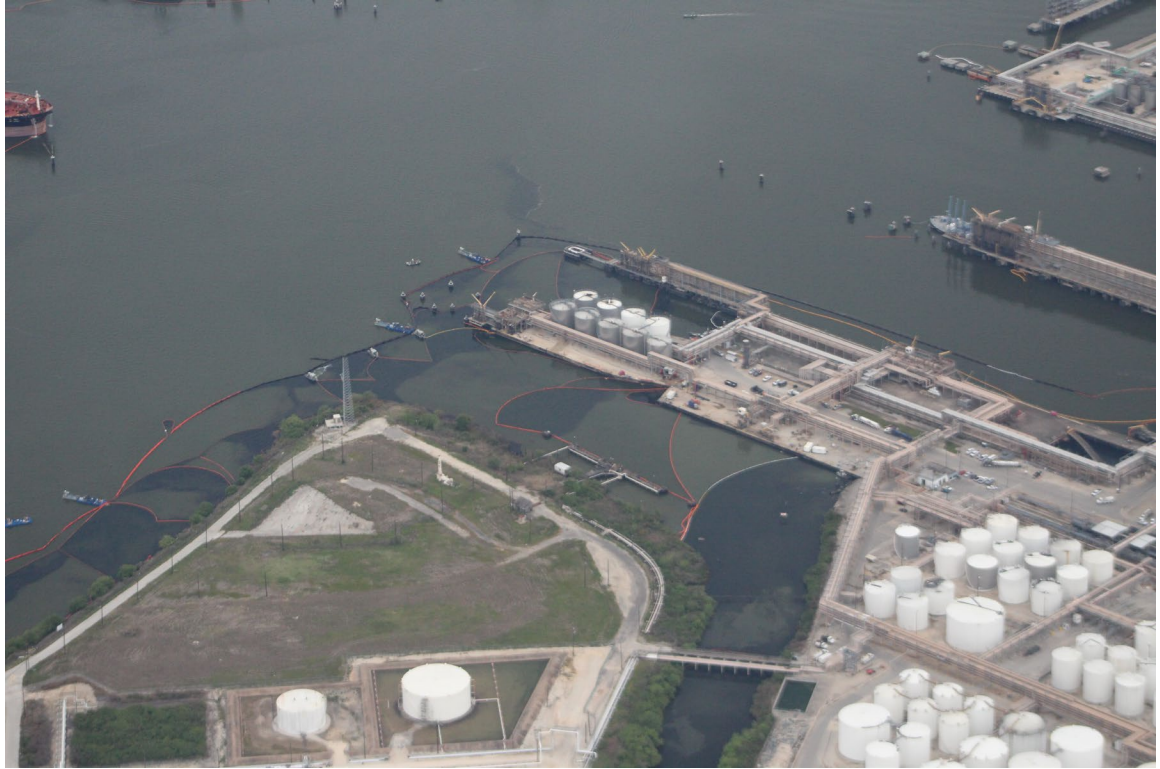
Figure 7 is an aerial image of the confluence area. As with prior flights, the boom network is clearly evident as is the trapped product behind the booms (visible as black material). There does not appear to be a significant change in the amount of trapped material from the previous mission. No significant leakage of product or sheen is present. An oblique of the same area confirms that most of the boom structure is holding product other than a small leakage of material in the northeast corner of the boomed area (Figure 8).

Figure 8: Oblique Image of the Ship Channel Boom Area, 3 April 2019, Flight 20
